Release Notes for the Catalyst 3750, 3560, and 2960 Switches, Cisco IOS Release 12.2(53)SE and Later

Revised August 18, 2010

Cisco IOS Release 12.2(53)SE and later runs on all Catalyst 3750 and 3560, and 2960 switches and on Cisco EtherSwitch service modules.

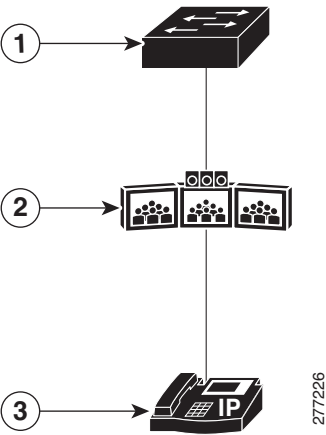
Figure 1 Phone-Codec-Switch Connection

You can use a Cisco IP phone as a user interface in a Cisco TelePresence System. See in [Figure 1](#). In this configuration, the IP phone must always be on and available for emergency calls. If the power to the codec in the Cisco TelePresence System fails, is disrupted or if the codec fails, the IP phone is not available.

1	Switch	3	IP phone
2	Cisco TelePresence System with a codec

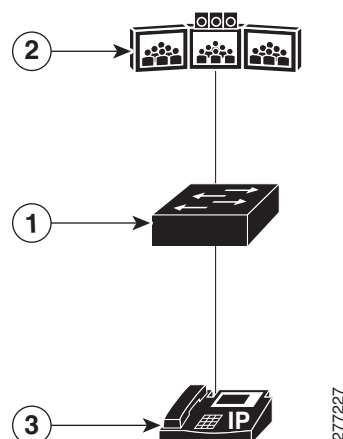
Figure 2 Phone-Switch-Codec Connection

Use the TelePresence E911 IP phone support feature to ensure that the IP phone is always on and available for emergency calls. When a CDP-enabled IP phone is connected to the codec through a switch, you can configure the switch to forward CDP packets from the IP phone only to the codec in the Cisco TelePresence System. The switch adds *ingress-egress port pairs* to the CDP forwarding table. An ingress-egress port pair is a one-to-one mapping between an ingress switch port connected to the IP phone and an egress switch port connected to the codec.

The switch forwards all CDP packets received on the ingress port to the egress port. If multiple IP phones are connected to the codec through a single port on the switch, only one phone communicates with it through the IP network. This phone is usually the one that sent the first CDP packet received by the codec.

1	Switch	3	CDP-enabled IP phone
2	Cisco TelePresence System with a codec
